MODIFICATION AND LABORATORY EVALUATION OF A SHIPBOARD  
MULTIFUNCTIONAL WAS... (U) NAVAL SURFACE WEAPONS CENTER  
DAHLGREN VA J A BYRNE ET AL. MAY 82 NSWC/TR-82-71

4. TITLE (and Subtitle) MODIFICATION AND LABORATORY EVALUATION OF A SHIPBOARD MULTIFUNCTIONAL WASTE INCINERATOR (MFI), PHASE II		5. TYPE OF REPORT & PERIOD COVERED Final

7. AUTHOR(s) J. A. Byrne W. W. Jones		6. PERFORMING ORG. REPORT NUMBER
9. PERFORMING ORGANIZATION NAME AND ADDRESS Naval Surface Weapons Center (G51) Dahlgren, VA 22448		8. CONTRACT OR GRANT NUMBER(s)

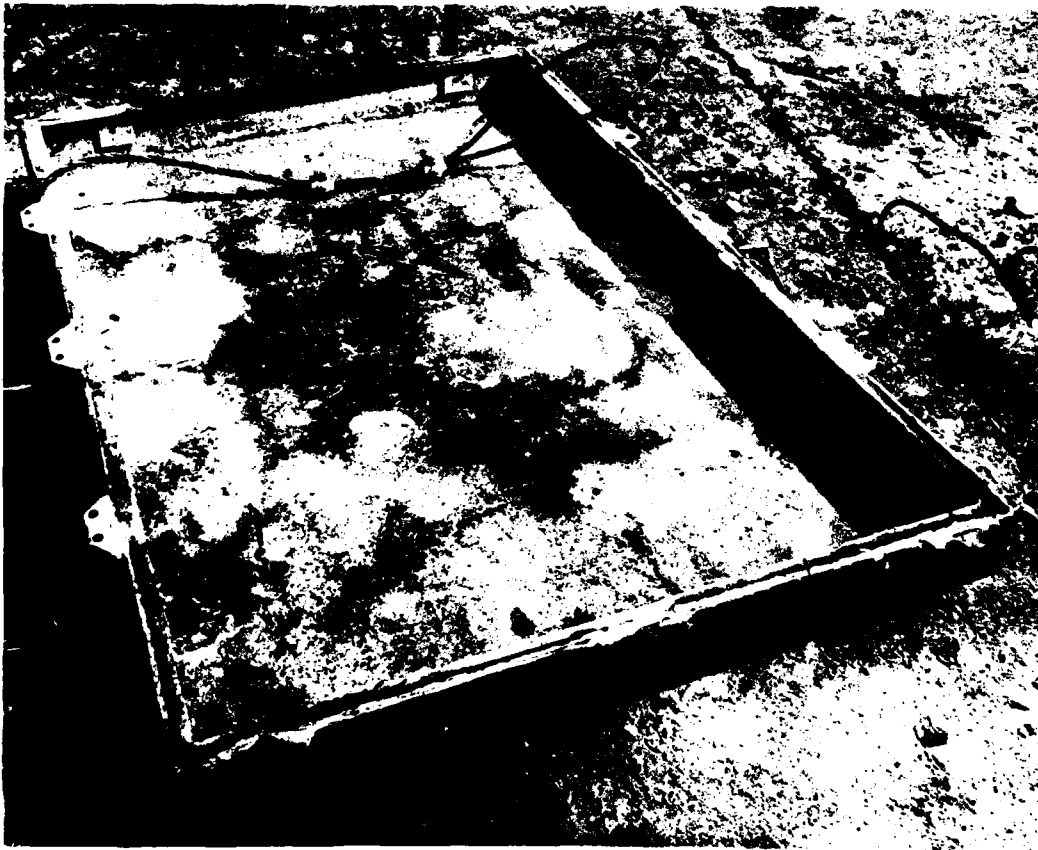
Figure 12. The Sewage Chamber Roof Metal Structure After the Refractory was Removed

The refractory material of the sewage chamber, partition, and ash door overhead was removed as shown in Figures 10 and 11. The condition of the metal structures is shown in Figures 12, 13, and 14. Figure 12 shows the sewage roof metal structure. Figure 13 is a front view of the sewage chamber wall metal structure. The partition's metal structure, shown in Figure 14, was repaired by replacing the destroyed air manifold pipe. The location of that pipe was also changed, so that an increased thickness of refractory material protected the pipe. All metal structures were then sandblasted and

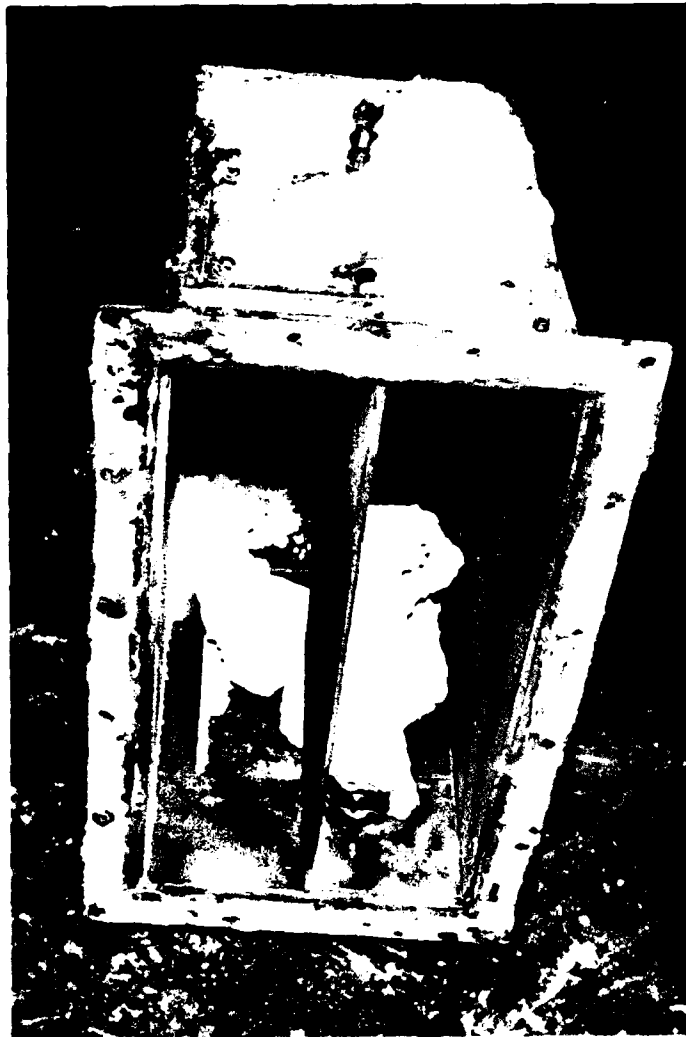
Figures 47 through 51 are a pictorial damage assessment of the MFI. Figure 47 is a view of the front of the MFI with the cooling chamber hatch removed; the damage is very apparent. Figure 48 gives a closer view of the damage in the cooling chamber. Figure 49 is a view of the cooling chamber exhaust port. The pieces of broken refractory blocked the air flow path through the chamber; this blocking would have caused a significant change in the main chamber draft had it occurred during the testing. This damage was assumed to have been a result of the fall rather than because of the vibration testing. Vibration may have cracked or weakened the structure to an extent where the damage from the fall was excessive, but no record could be obtained to prove this. Figure 50 shows the refractory that entered the fan plenum, and Figure 52 illustrates some of the damage to the outer jacket. The main and sewage chambers suffered very minor damage, as shown in Figures 52 through 58.

Figure 50. Refractory in the ID Fan Plenum

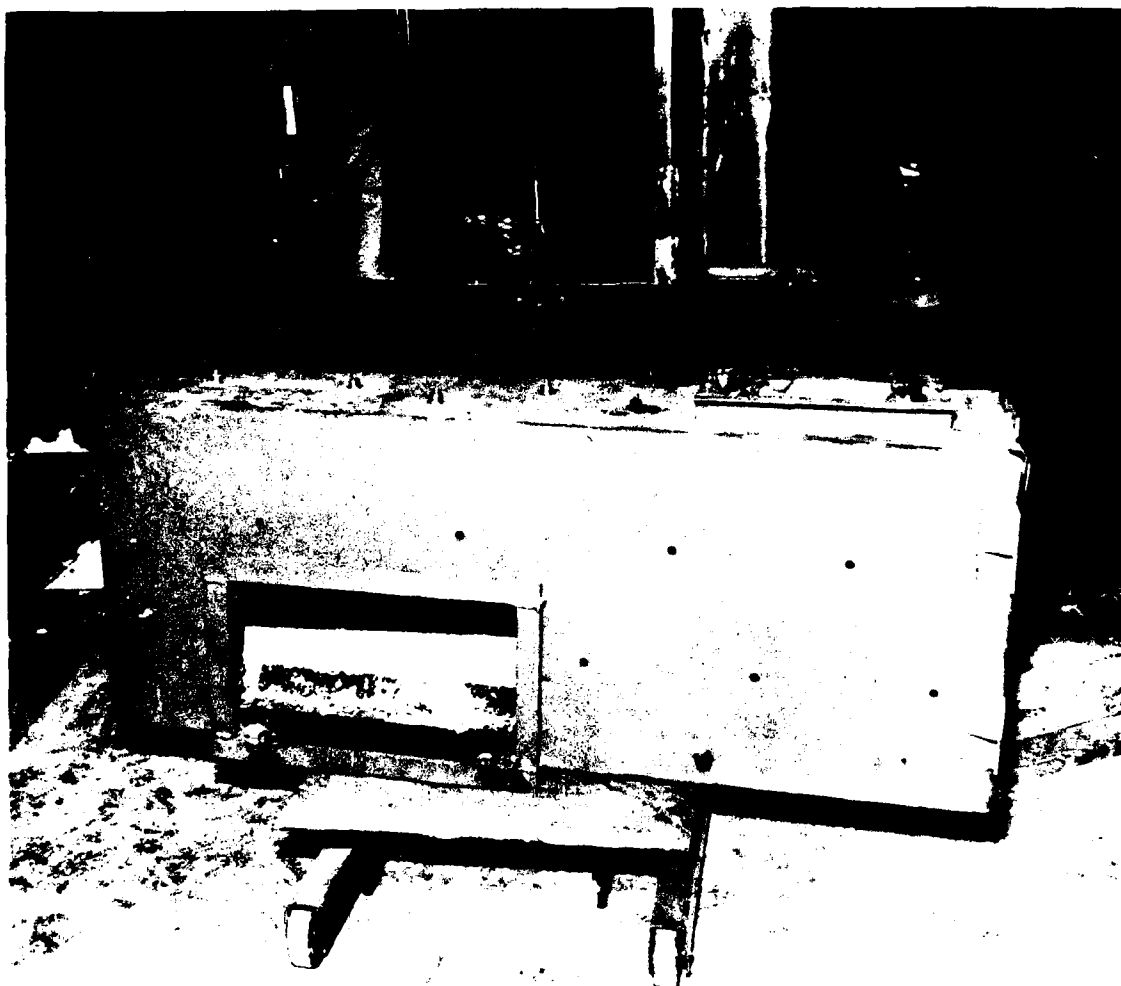
Figure 61. Vertical Section of Cooling Chamber, with the Exhaust Port at the Lower Left and Cooling Fan Port at the Upper Right

The cooling chamber was redesigned and rebuilt in two sections, as shown in Figures 59 through 62. Figure 59 shows the horizontal section of the cooling chamber with the two side walls cast and the forms in place. Figure 60 is a view of the bottom of the horizontal section, detailing the circular access port and the rectangular section exhaust. Figure 61 is a photograph of the vertical section showing the exhaust port and the metal form that provided a smooth transition from refractory to metal. Figure 62 is a view of the top portion of the vertical section. The large rectangular opening is the portion that mates with the horizontal section. The smaller, flanged opening is for the exhaust from the cooling jacket fan. The angled form is used with metal vanes to redirect the air flow into the main stream passing through the section. The metal forms were liberally greased to prevent the refractory from adhering. Using this method also provides much better "set" refractory tolerances than would be achieved using wood forms.

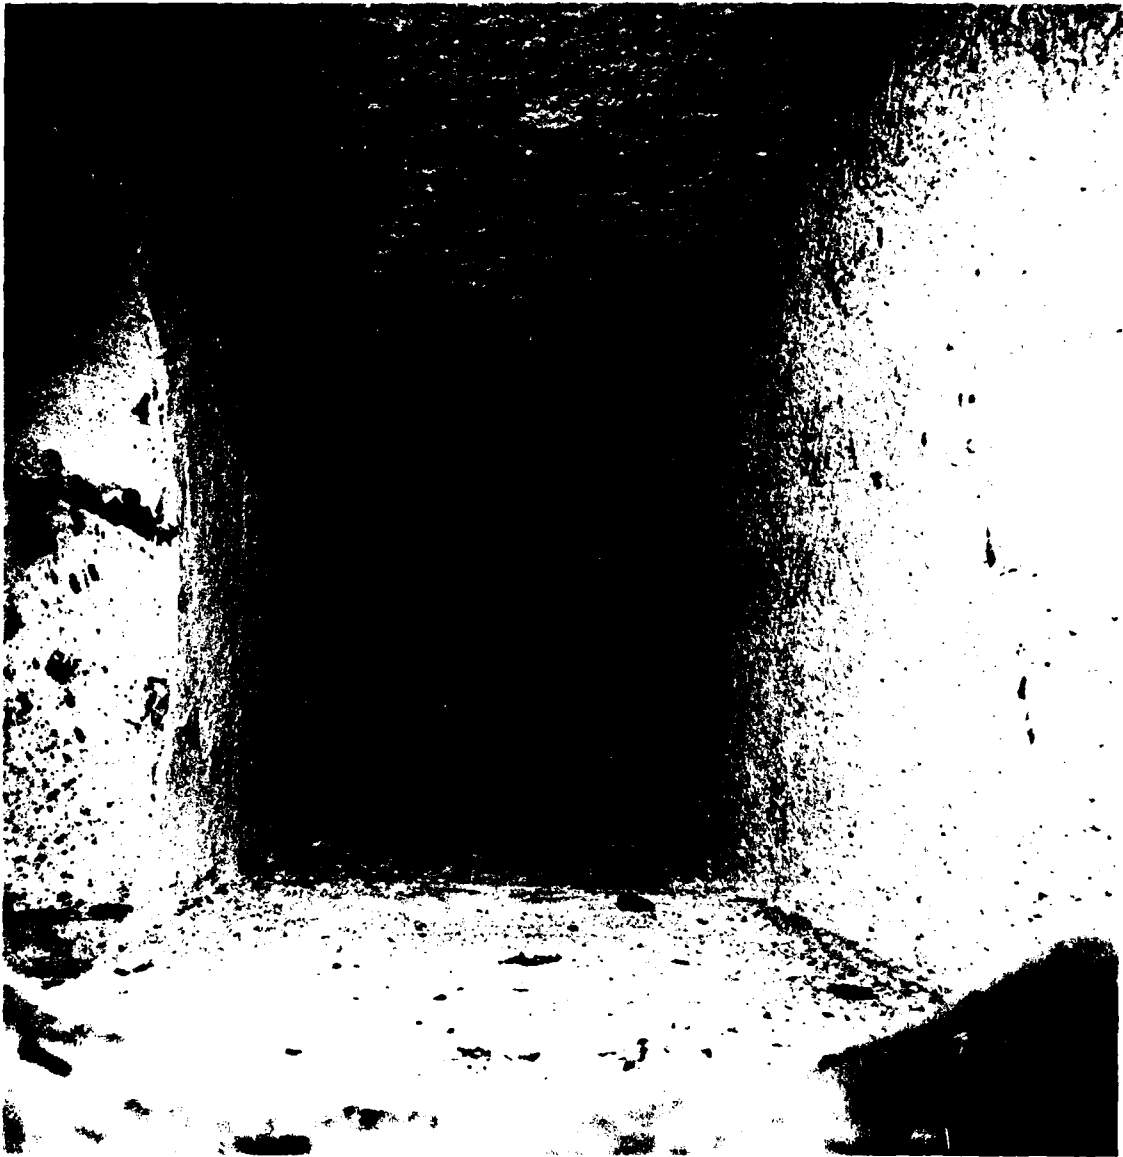
Figure 63. The Cooling Chamber Horizontal Section, with Cured Refractory

The two sections were mated and inverted. A burner was installed in the access port, and the refractory was cured to 1,800°F. As Figure 63 shows, the cure was successful. The unit was mated to the sewage chamber and base frame, as shown in Figure 64, and moved back to the vibration test site.
